Remarks
Of the Republic of Poland
as:
the state of registration and operator

on the draft Final Report
regarding
the investigation into the accident of the Tu-154M tail number 101 aircraft
which occurred on 10 April 2010
drafted by
the Interstate Aviation Committee (IAC)

Warsaw, 19 December 2010

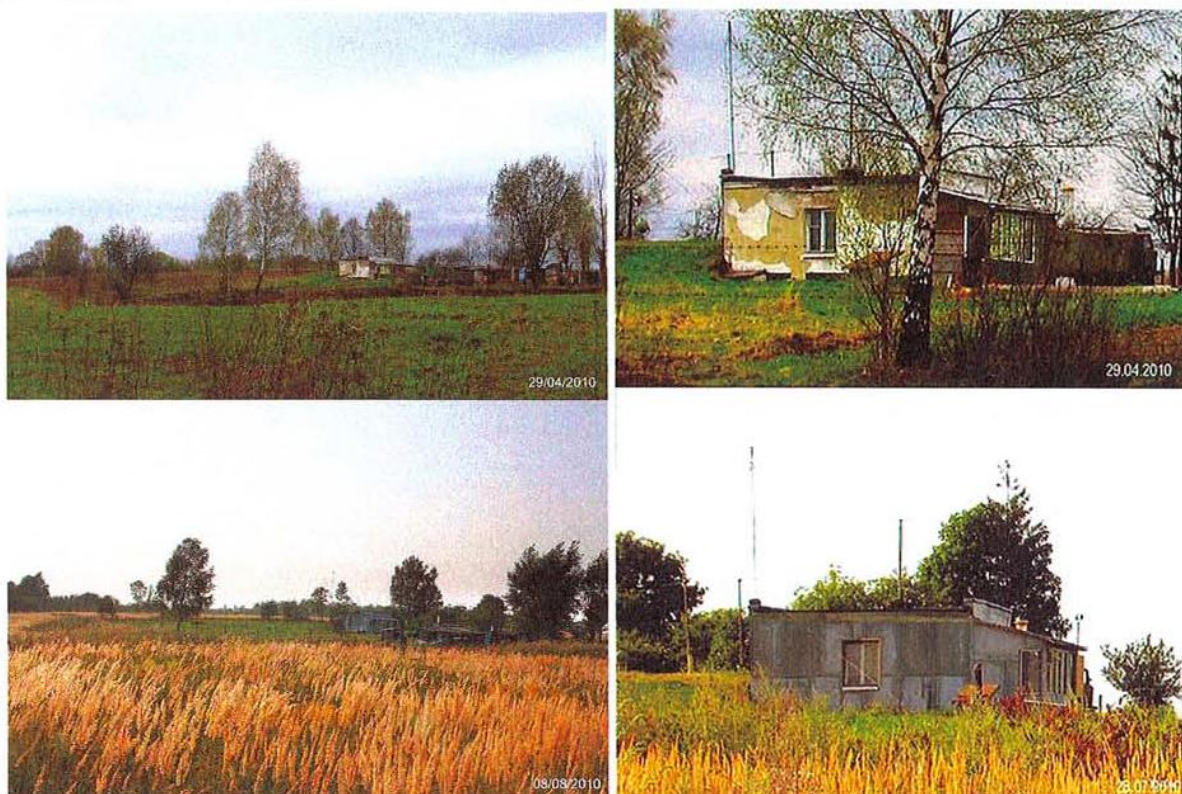
In accordance with the minutes of interrogation, dated 3 May 2010, of Yak-40 crew commander, which landed at the Smolensk “Severny” aerodrome on 10 April 2010 (Before the arrival of the Tu-154M aircraft), the middle NDB did not work reliably. Indications varied within $\pm 10^\circ$. The probable cause of unstable performance of the NDB were trees growing in the beacon antenna field, by far exceeding the height of the antenna mast, the presence of an overhead power line and the ravine in the immediate vicinity of the NDB. These factors may have affected the NDB antenna pattern.

Differences in the state of tree - the area of the NDB, around 1000 m from the threshold of runway 26

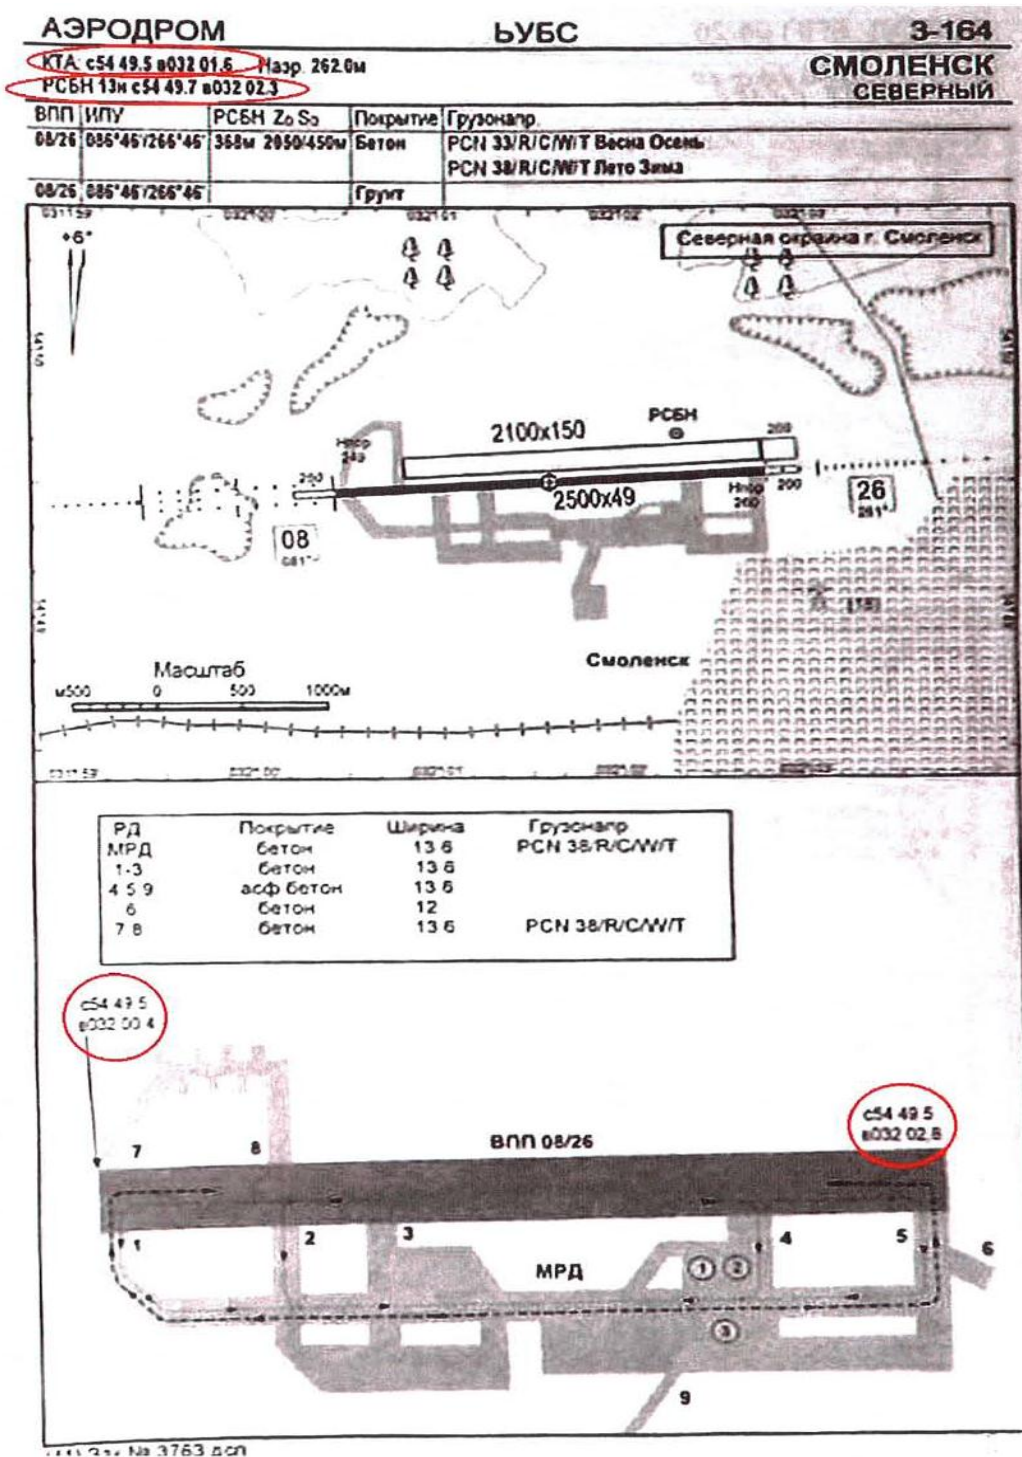
Smolensk “Severny” aerodrome diagram provided to the Polish side in 2009, indicating the geographical coordinates of runway thresholds and the ARP (without indicating reference system)

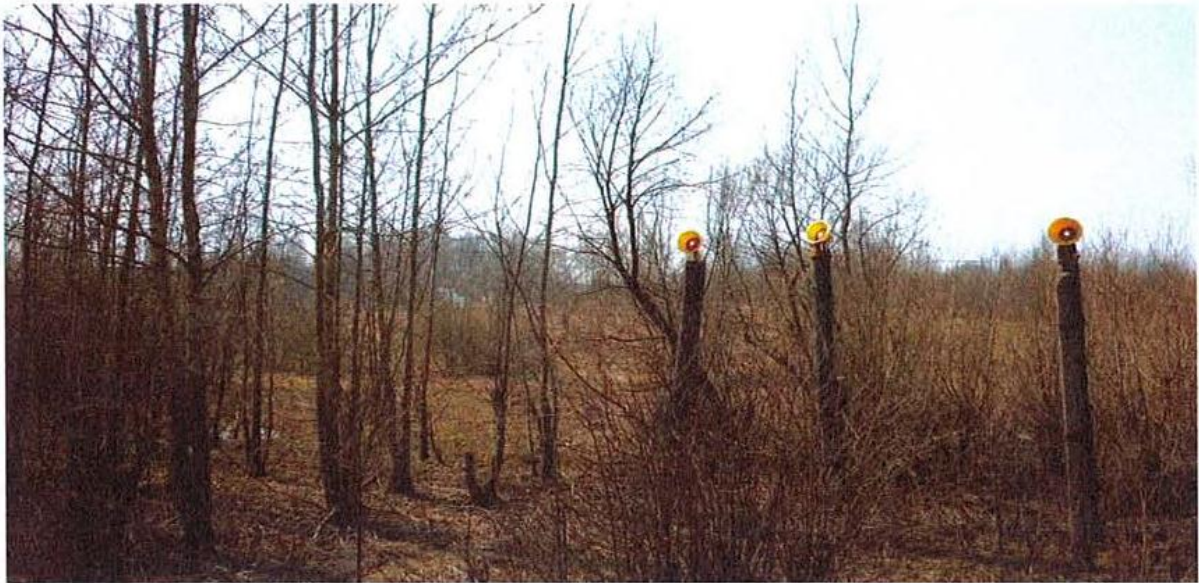
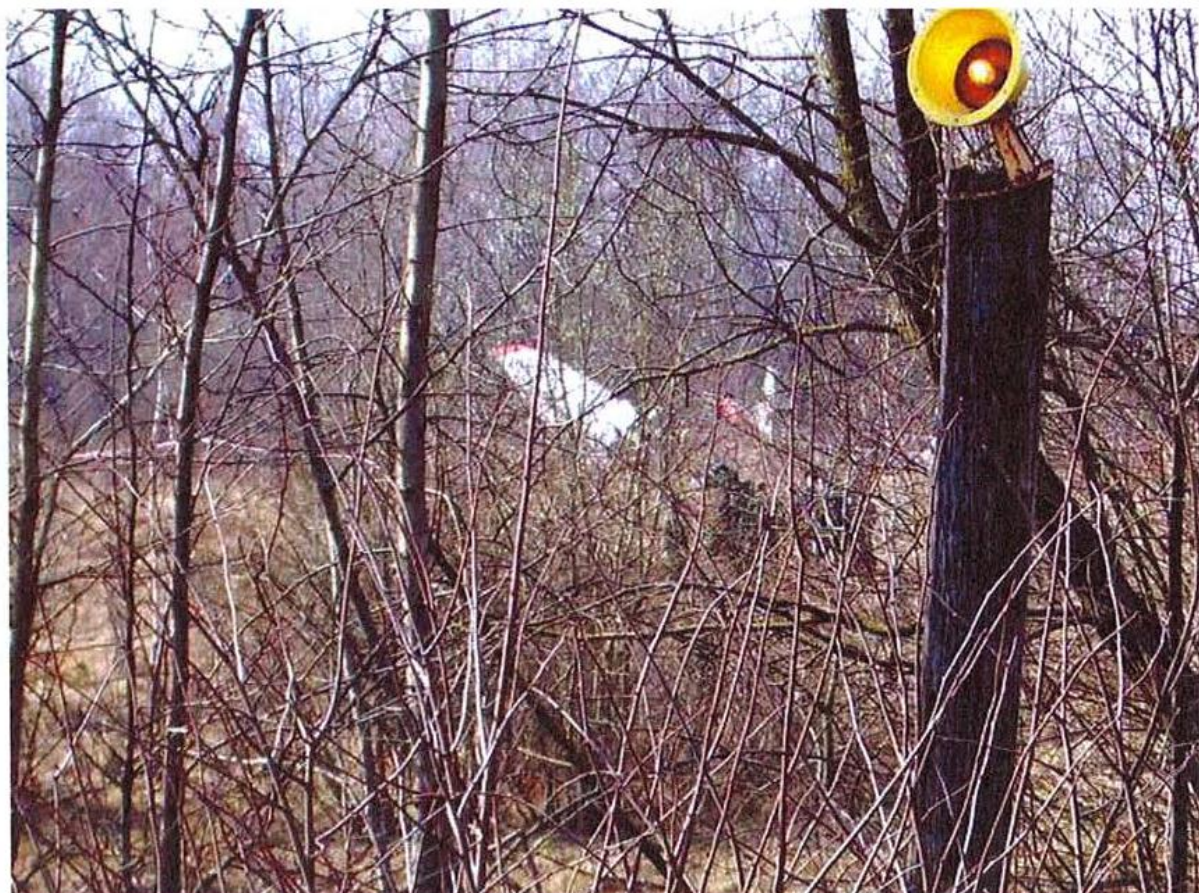
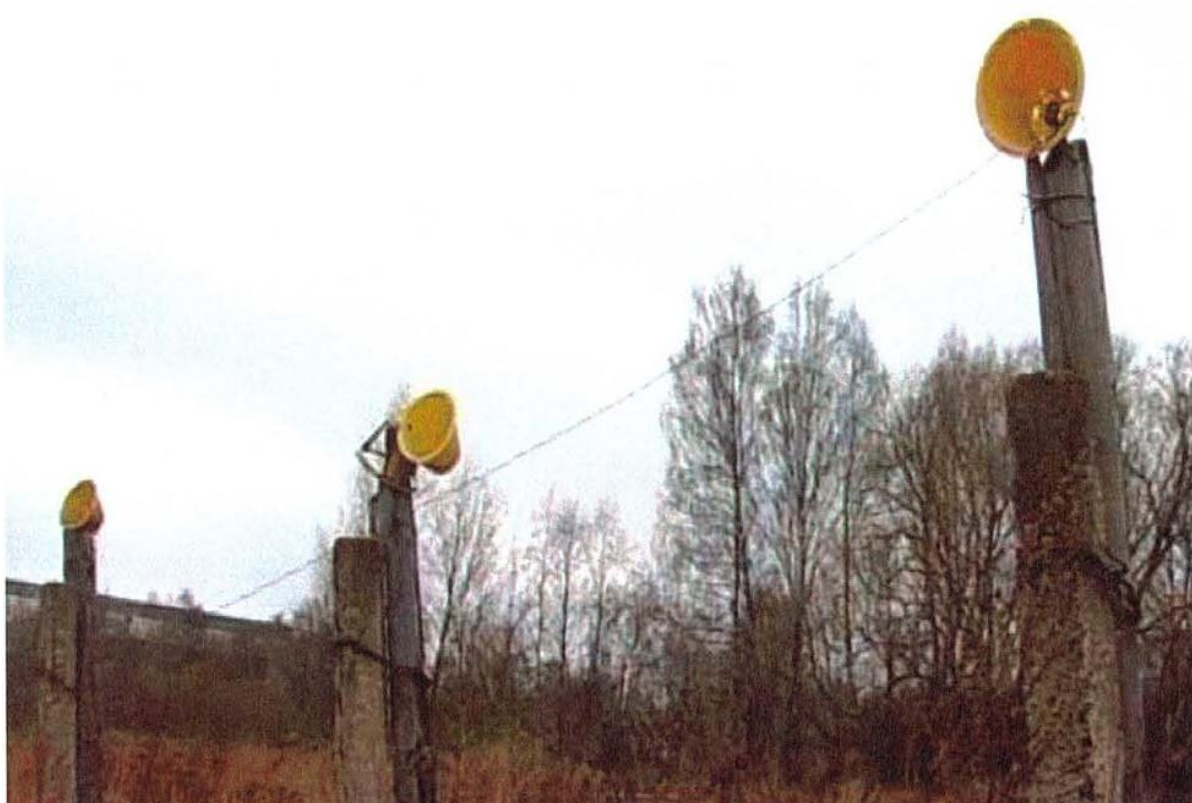
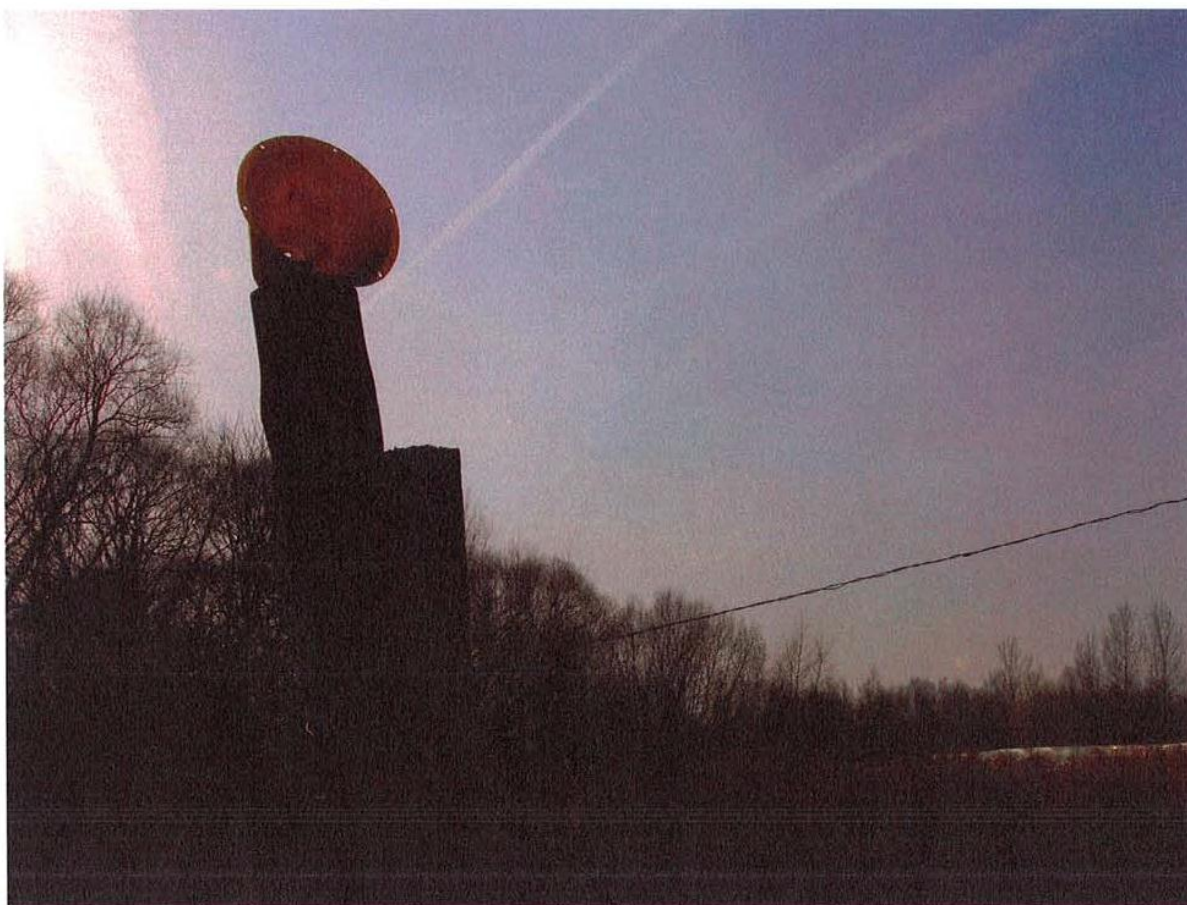
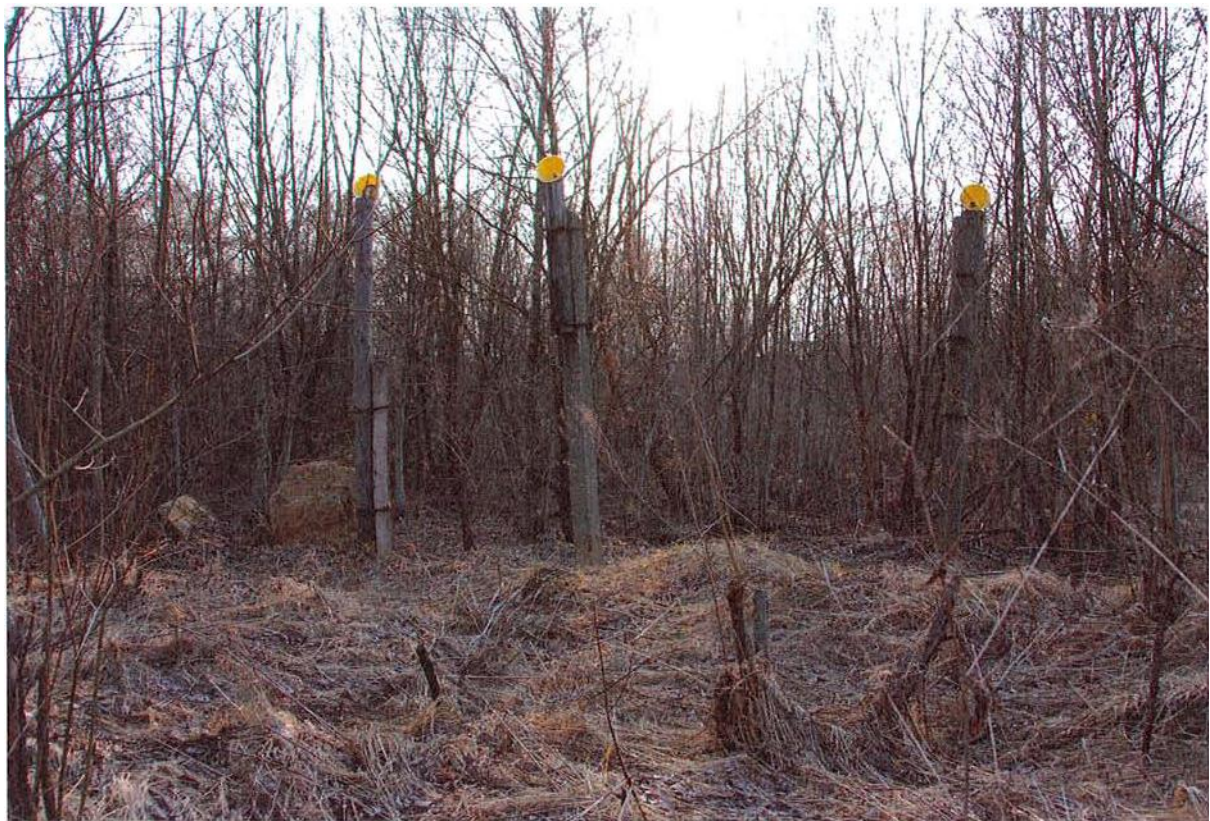
The photographic documentation made on 10 April 2010 shows that the approach and horizon lights at the Smolensk “Severny” aerodrome did not belong to the LUCH-2MU device as described in the Report in point. 1.8. “Landing navigational equipment and UWD”, item “aerodrome lighting equipment”.

The appearance of the “LUCH-2MU” lighting equipment at the Smolensk “Severny” aerodrome on 10 April 2010

The above photographic documentation shows, that the lighting elements of the lighting system of the Smolensk “Severny” aerodrome originated from an unspecified device, did not have mirrors and focusing lenses, and did not possess a vertical and horizontal plane lighting angle adjustment function.

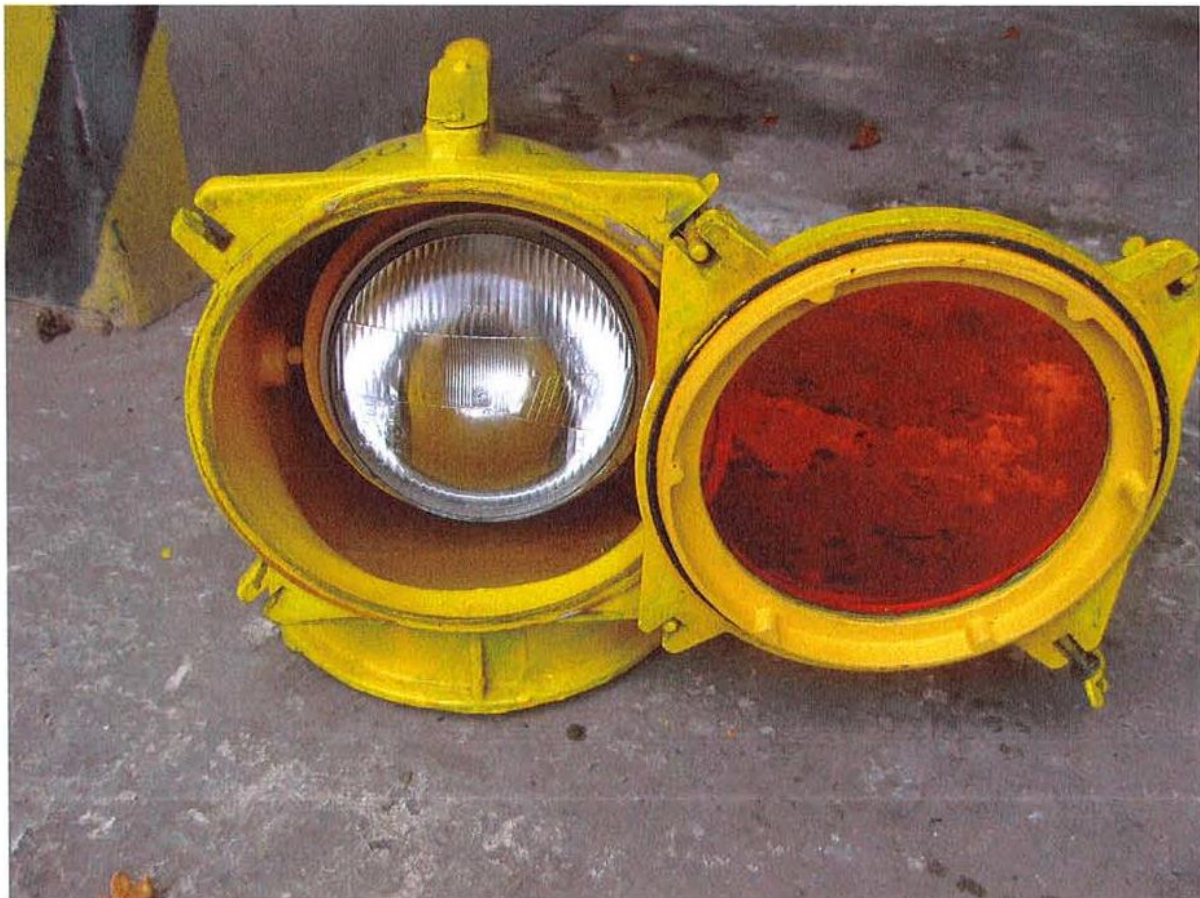
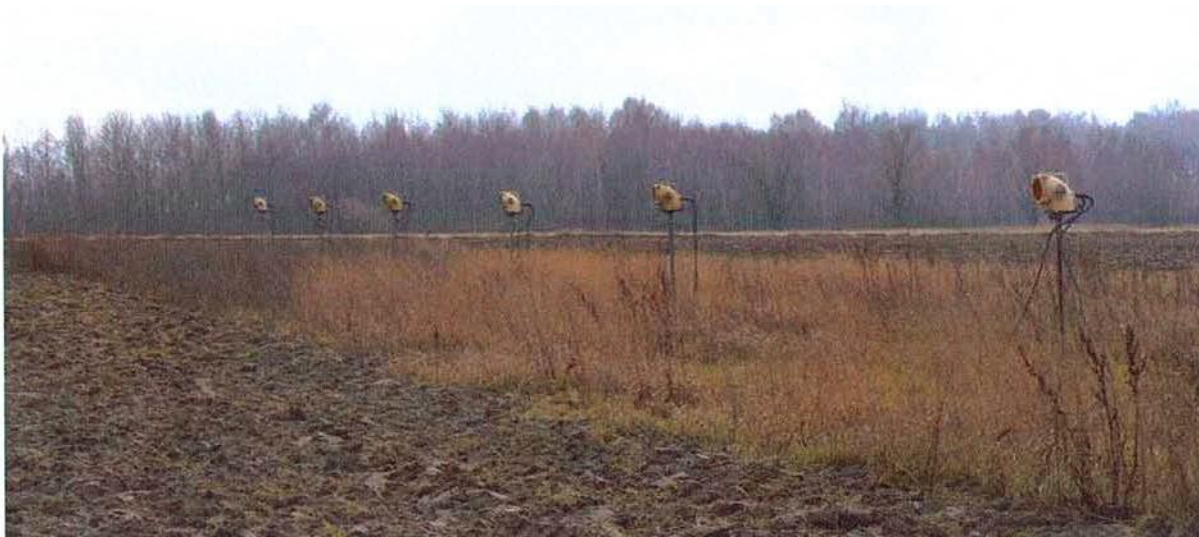
This is what the elements of the LUCH-2MU lighting system should look like – the below pictures

Do not come from Smolensk “Severny” aerodrome

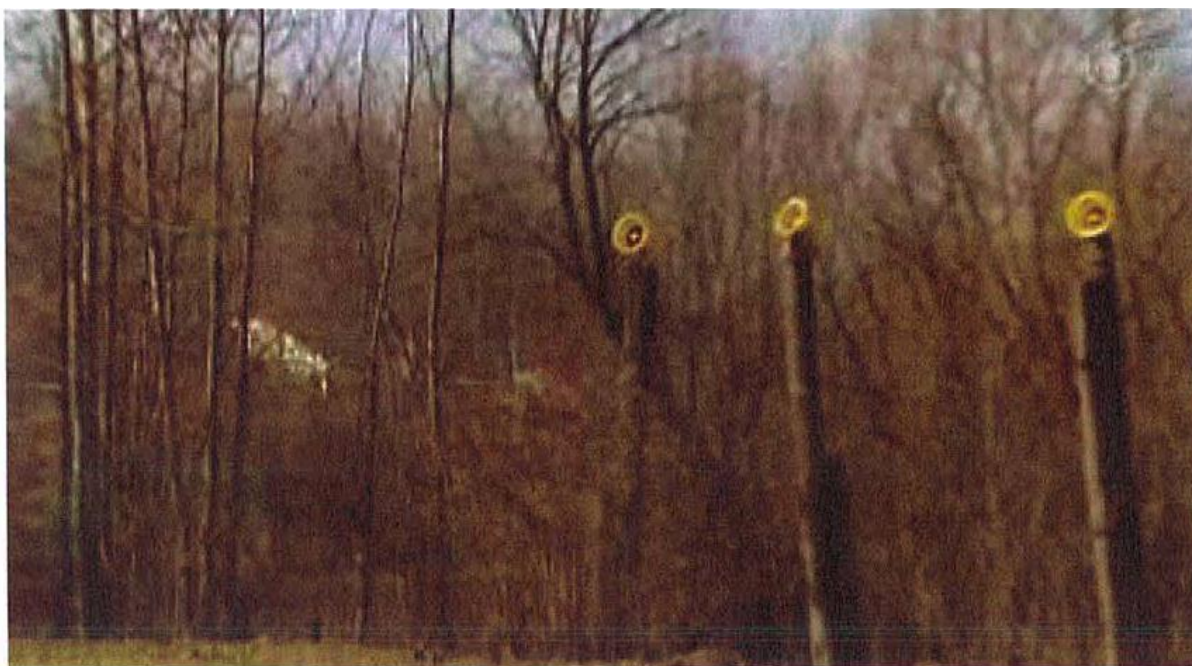
Moreover, information contained in point 1.16.7 “*Assessment of the lighting system visibility*” which pertains to the statement, ‘*that the crew could not even make visual contact with the first (900 metres from the DS)*’ row of approach lights may be true, as the elements of the lighting system laid out at the Smolensk “Severny” aerodrome were not of headlight type, and their photometric characteristics were far from the required standards (pictured below).

Note the text in figure 42: is $\Delta L = 755$ m and should be $\Delta L = 725$ m.

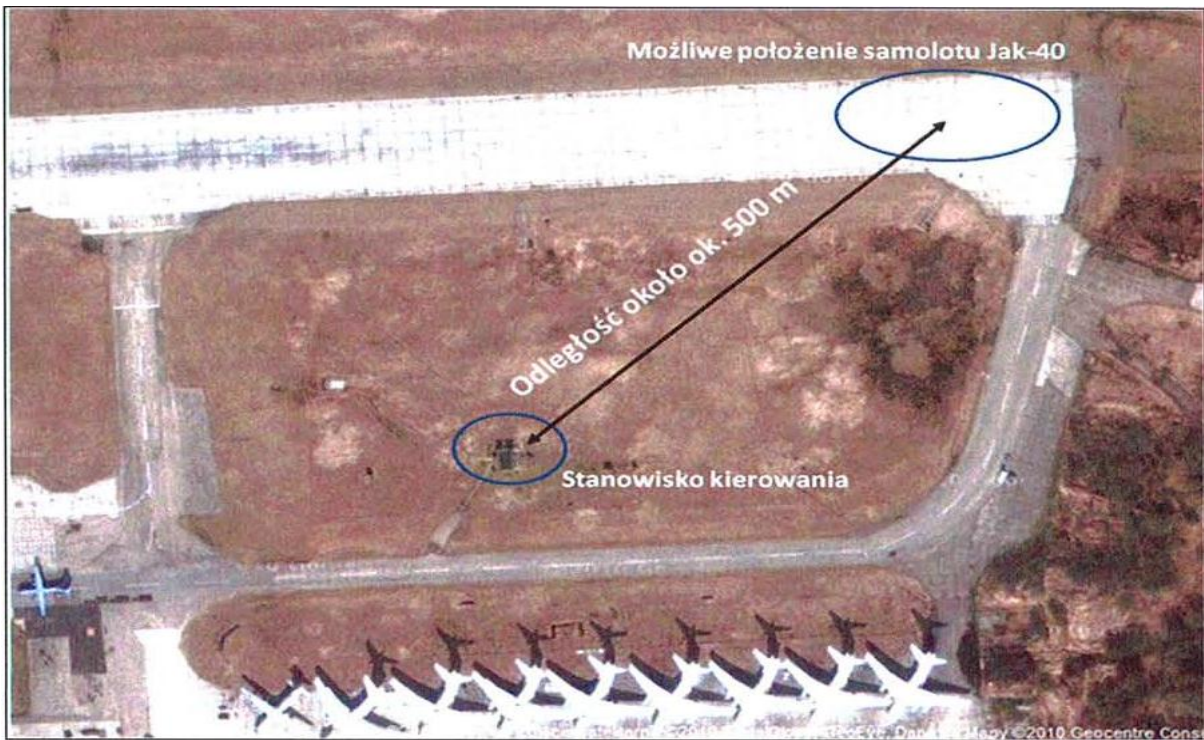
The CATC saw the Yak-40 plane just above the DS 26 threshold. An analysis of the distance between the position of individual objects (see picture below) shows that the actual visibility during Yak-40 aircraft’s landing was no greater than 500 metres.

Possible location of the Jak-40 aeroplane

Distance approx. 500 m

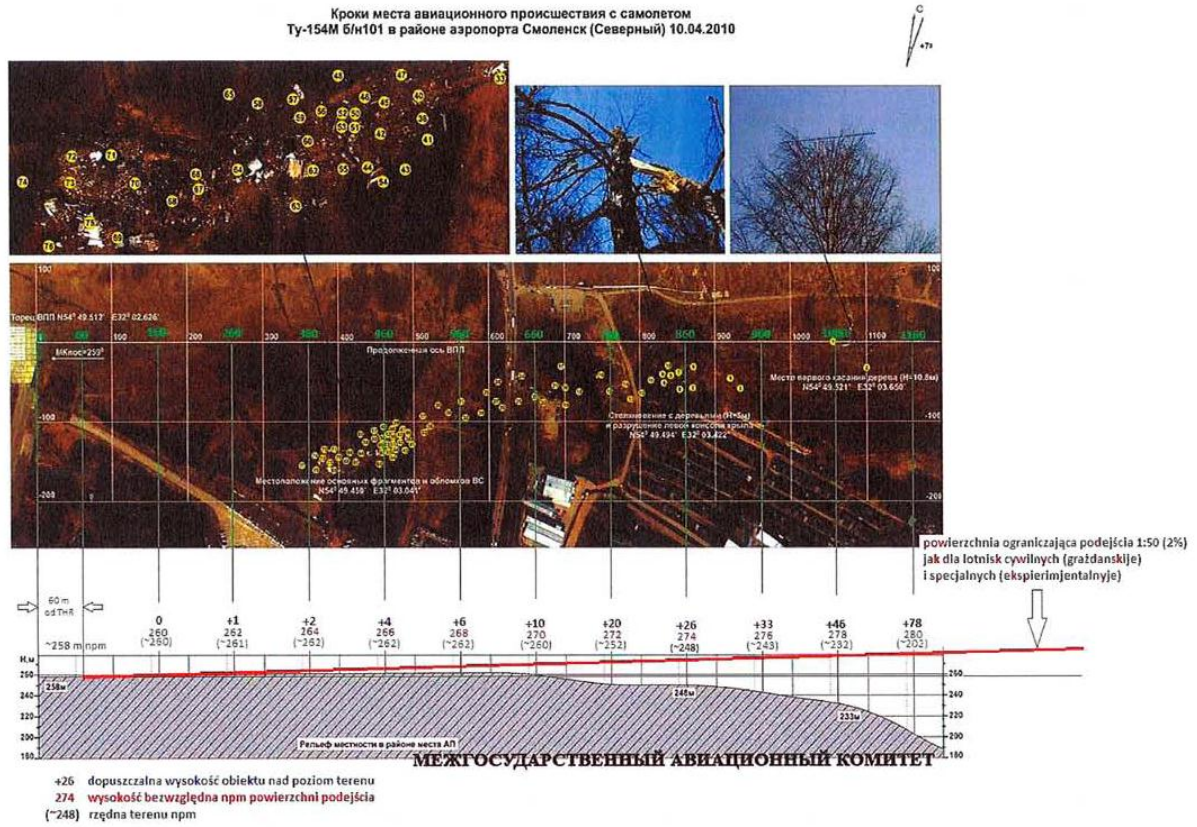
OPTION II

approaches 1:50 (2%) for civil aerodromes

- + 26 permissible building height above ground level
- 274 absolute height above sea level of approach surface
- (-248) ground ordinate above sea level

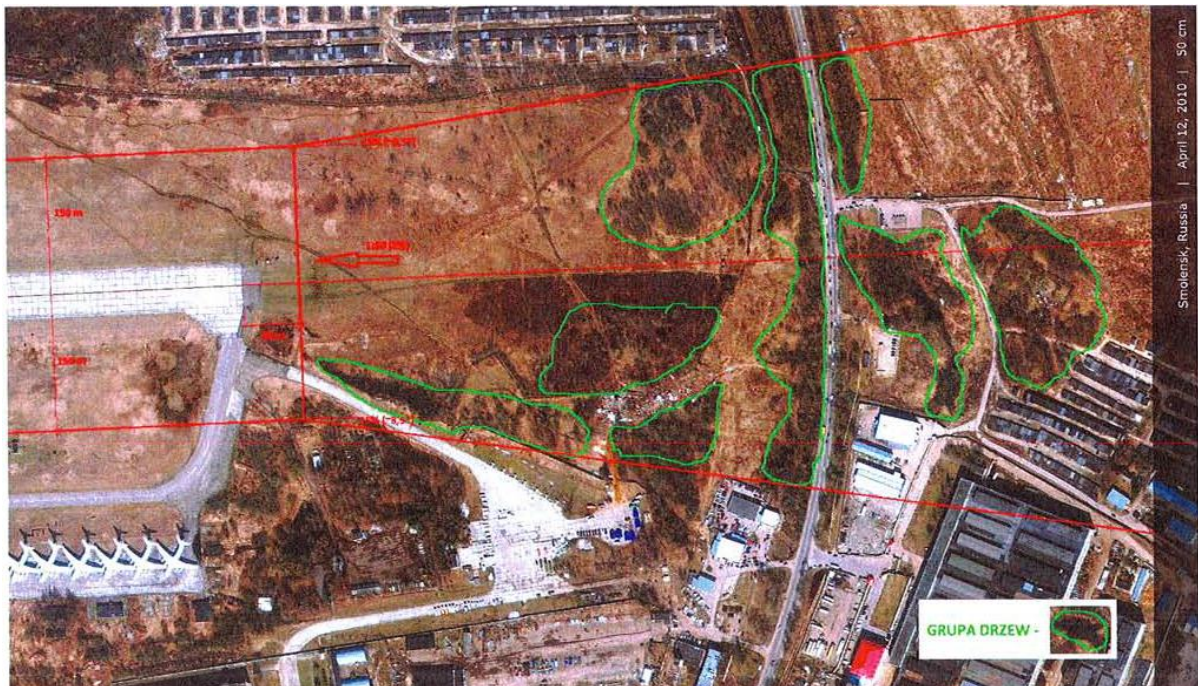
CLUSTERS OF TREES

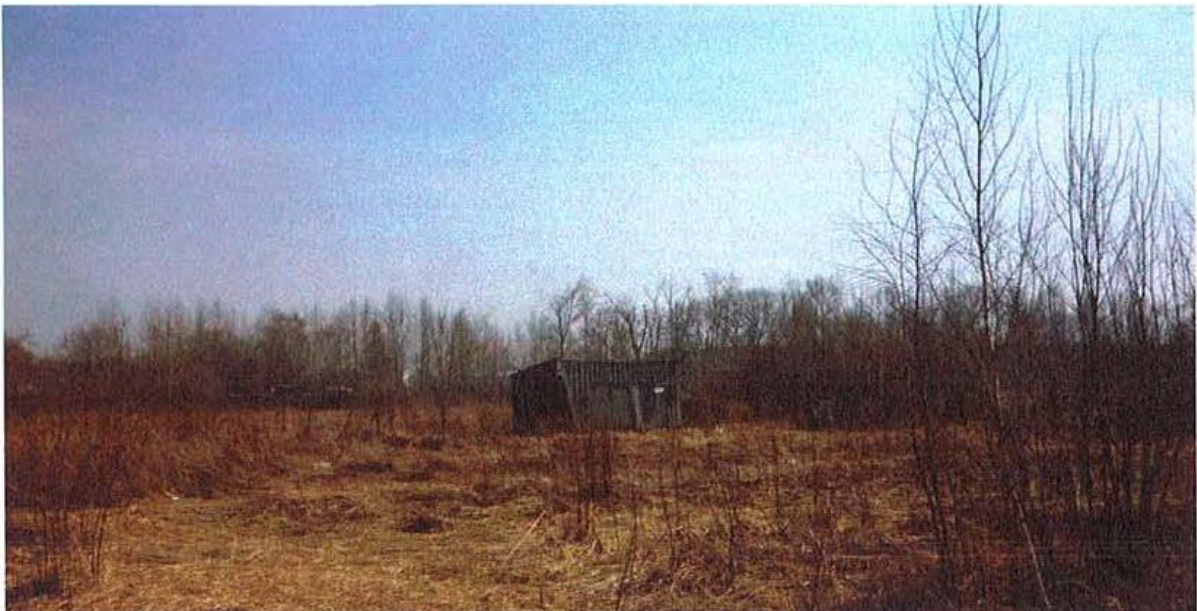
In both options, it was found that the area situated at a 300 m to 850-900 m distance from the DS 26 threshold, within the approach limiting surface from the 259° direction, was overgrown with plenty of shrubs and featured clusters (groups) of trees of a height of the order of 20 - 25 m above ground level, which exceeded (sometimes significantly, by approximately up to 15 m) the maximum admissible height of objects set by the above stated limiting surface, particularly in the area of the motorway intersecting the approach (400 m -700 m from the DS 26 threshold).

Trees and shrubs app. 500 m from the DS 26 threshold (view toward 259° approach)

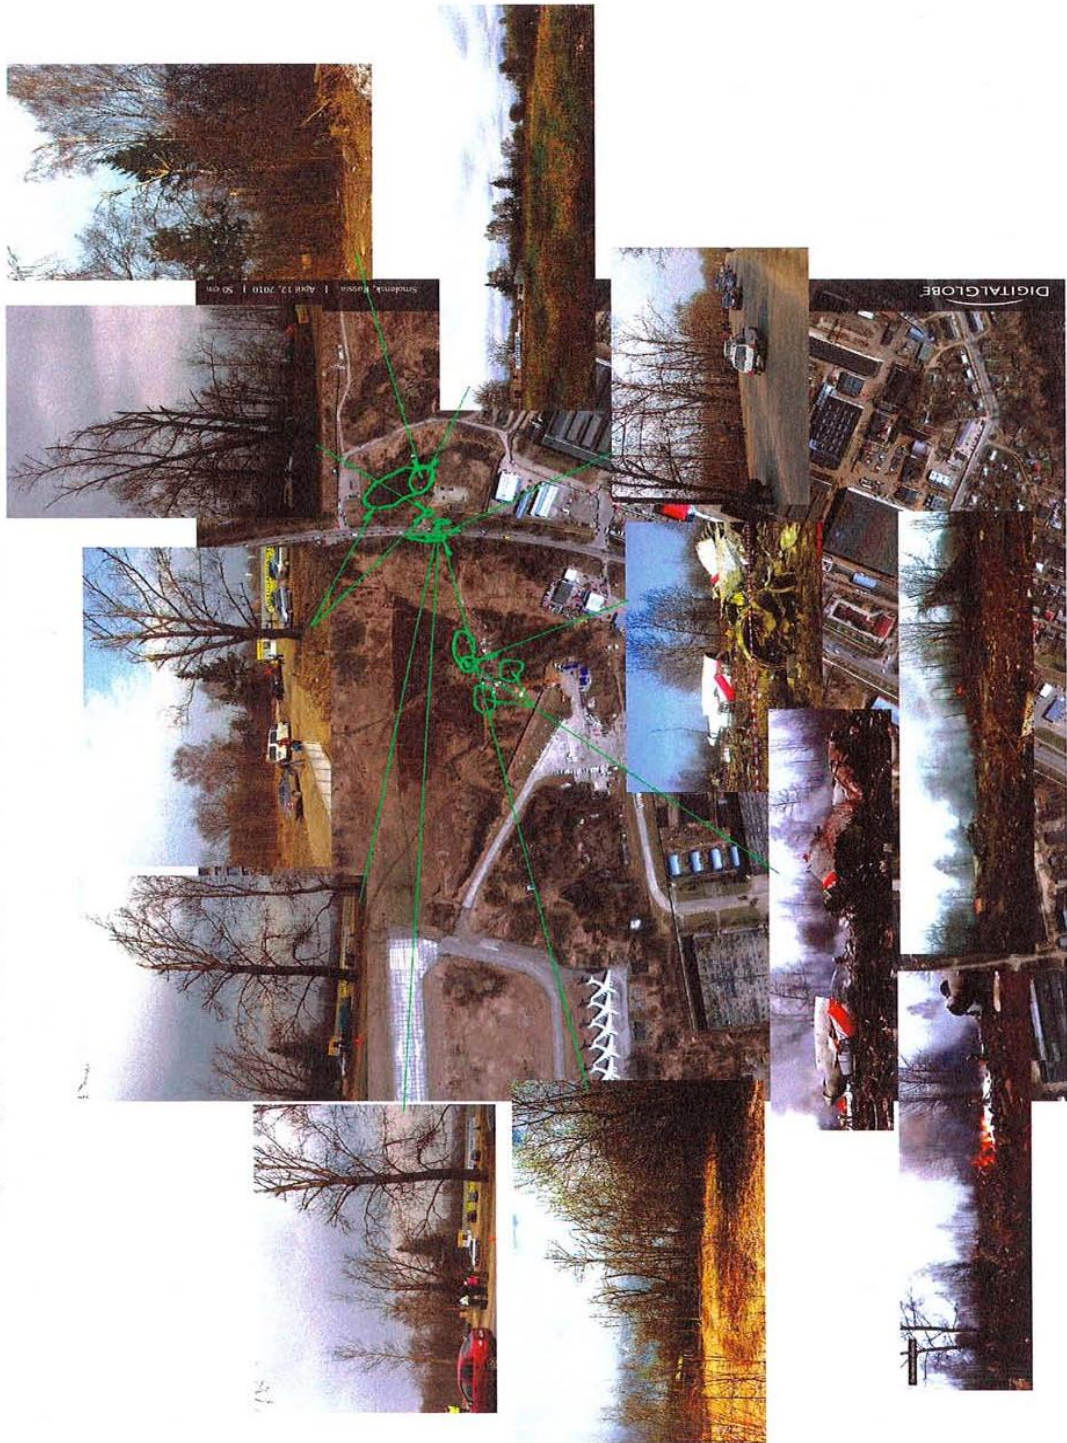
Distribution of some clusters of trees in the approach surface area

This is inconsistent with the Polish, Russian and ICAO (Annex 14) regulations. These clusters of trees in question constituted a real threat to aircraft approaching for landing on the DS 26, especially in the difficult weather conditions that prevailed on 10 April 2010. Moreover, the trees and shrubs growing in the area before the DS 26 threshold obscured lights from the lighting system for the crews and limited SKL personnel's already obstructed visibility (due to fog) from SKL toward the 259° approach. In these circumstances, one cannot claim the aerodrome was fully operational and ready to accept aircraft, particularly those of HEAD status. It should be noted, that *"The act of technical review of the Smolensk "Severny" aerodrome to accept special flights"* dated on 5.04.2010, merely states that, quote: *"... at a distance of 1 to 4 km from the runway threshold, there are no obstacles measuring over 10 m in height relative to the runway threshold and from 4 km to the end of the approach strip, measuring 50 m relative to the runway threshold"*. No information is given about any possible obstacles situated at a distance of up to 1 km from the DS 26 threshold, i.e. in the area where representatives of the Polish side had found clusters of tall trees. The Polish side's assessment of the forest stand having exceeded permissible height levels along the DS 26 approach is confirmed by the mass logging of trees and shrubs in that area, which took place after the accident, as had been established based on the available photo documentation (picture below).

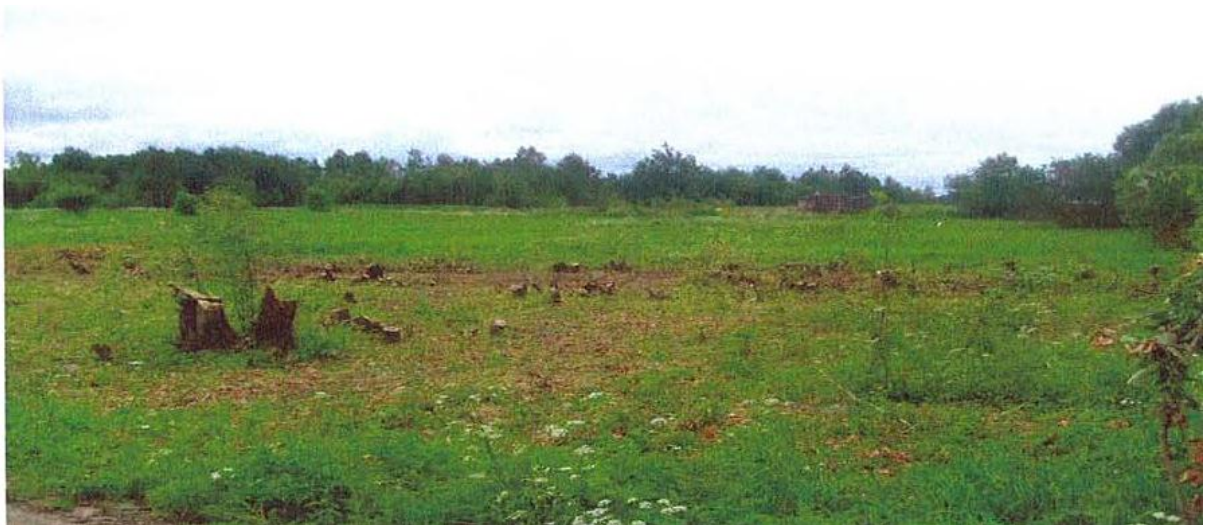
Logged trees and shrubs – app. 600 m from the DS 26 threshold (view toward the DS).

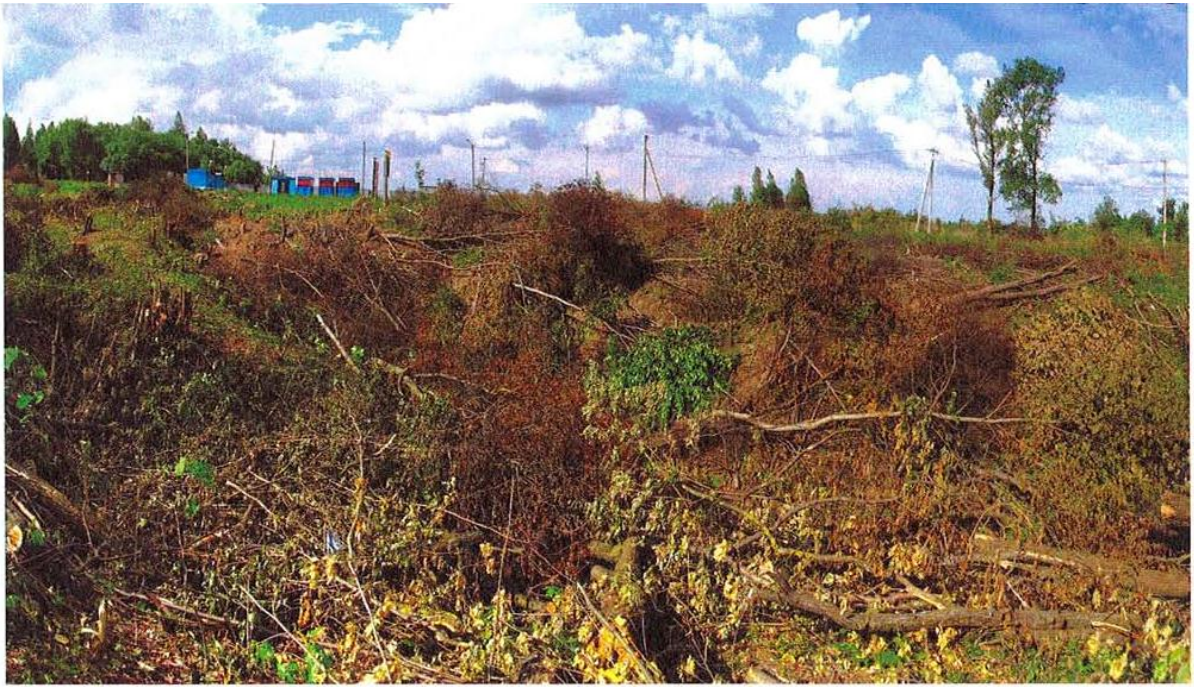
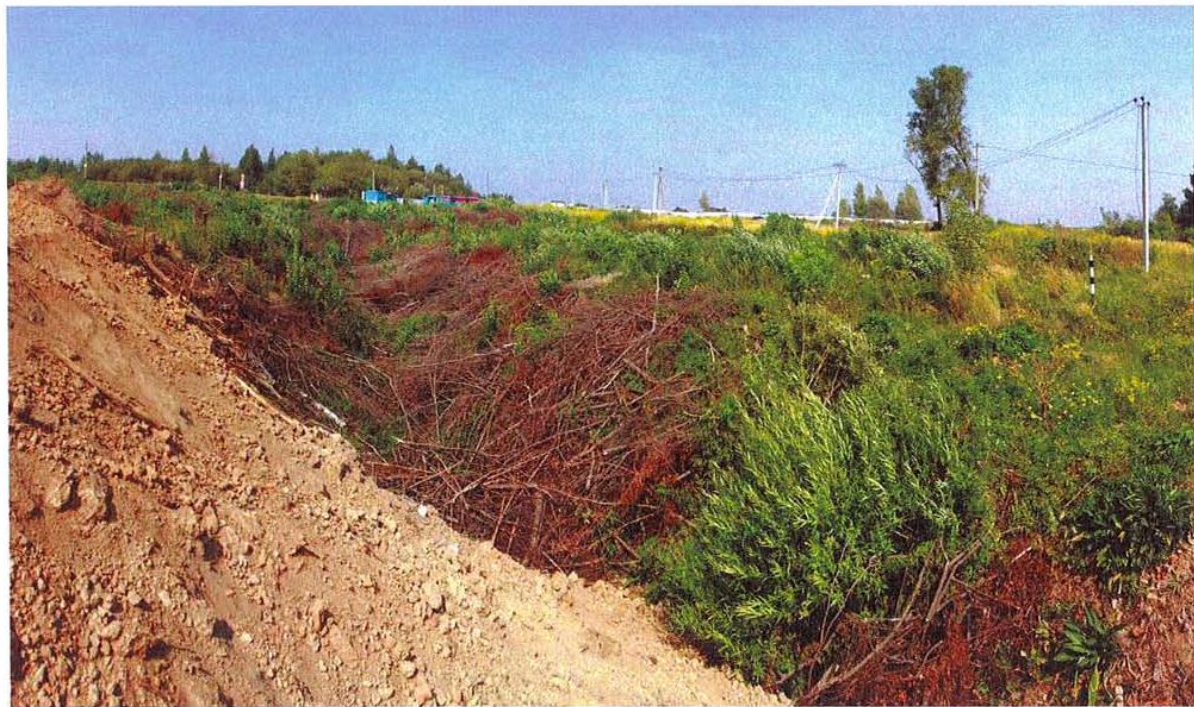
Logged trees and shrubs at the approach axis, at app. 700 m distance from the DS 26 threshold.

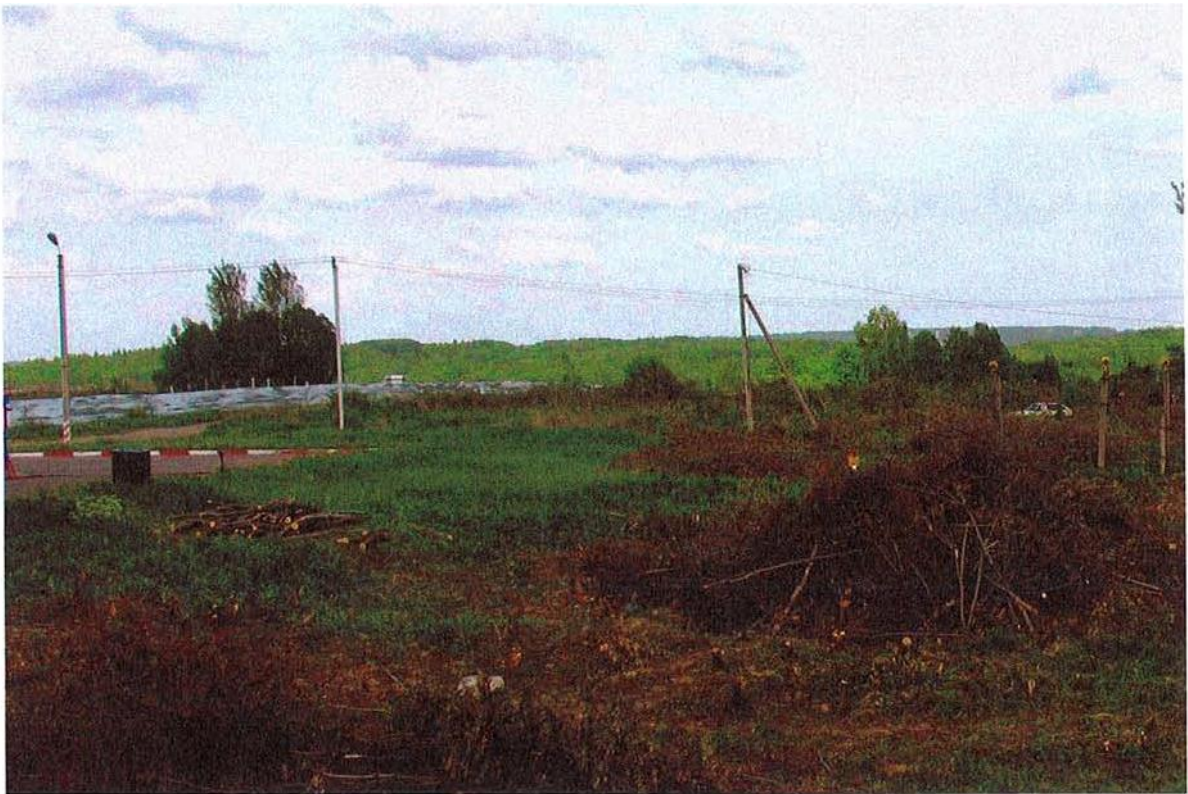
Logged trees and shrubs at the approach axis, at app. 700 m distance from the DS 26 threshold.

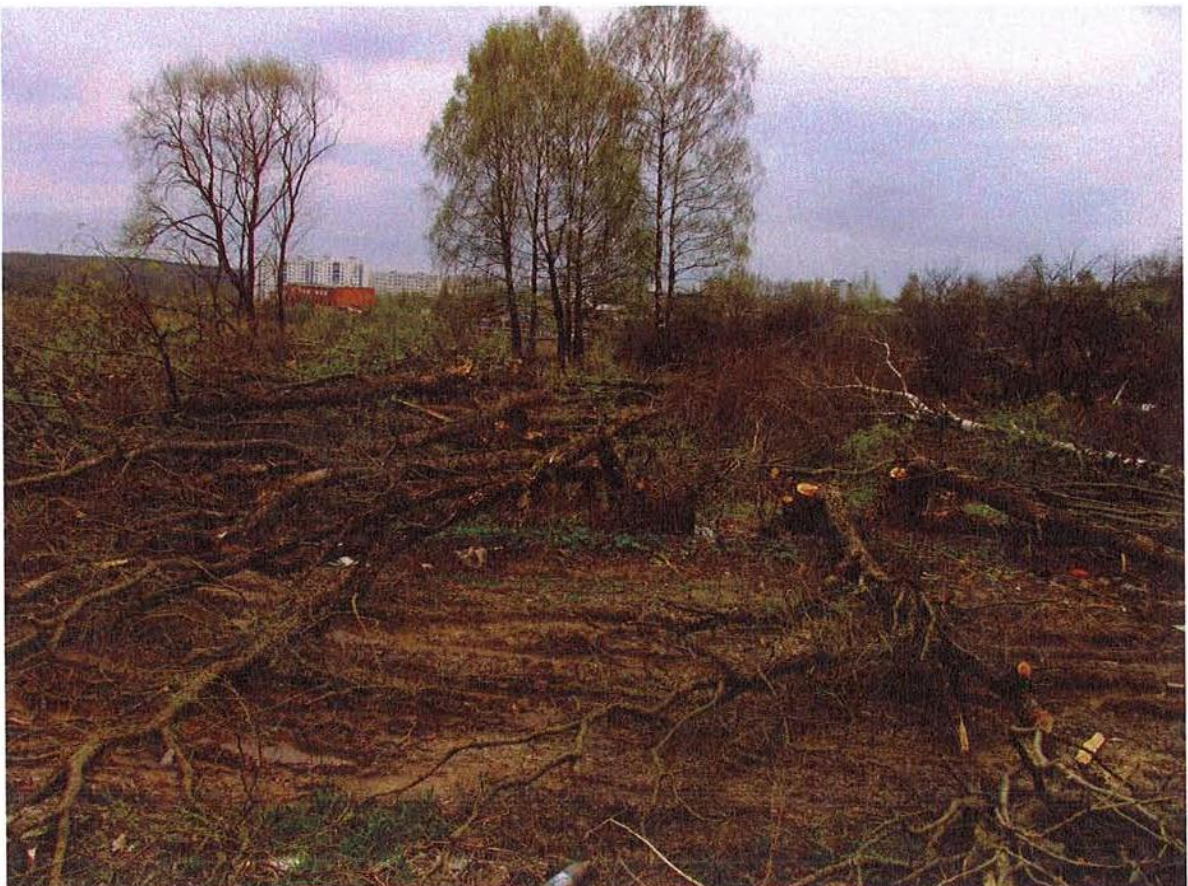
Logged trees in the BRL area app. 900 m from the DS 26 threshold

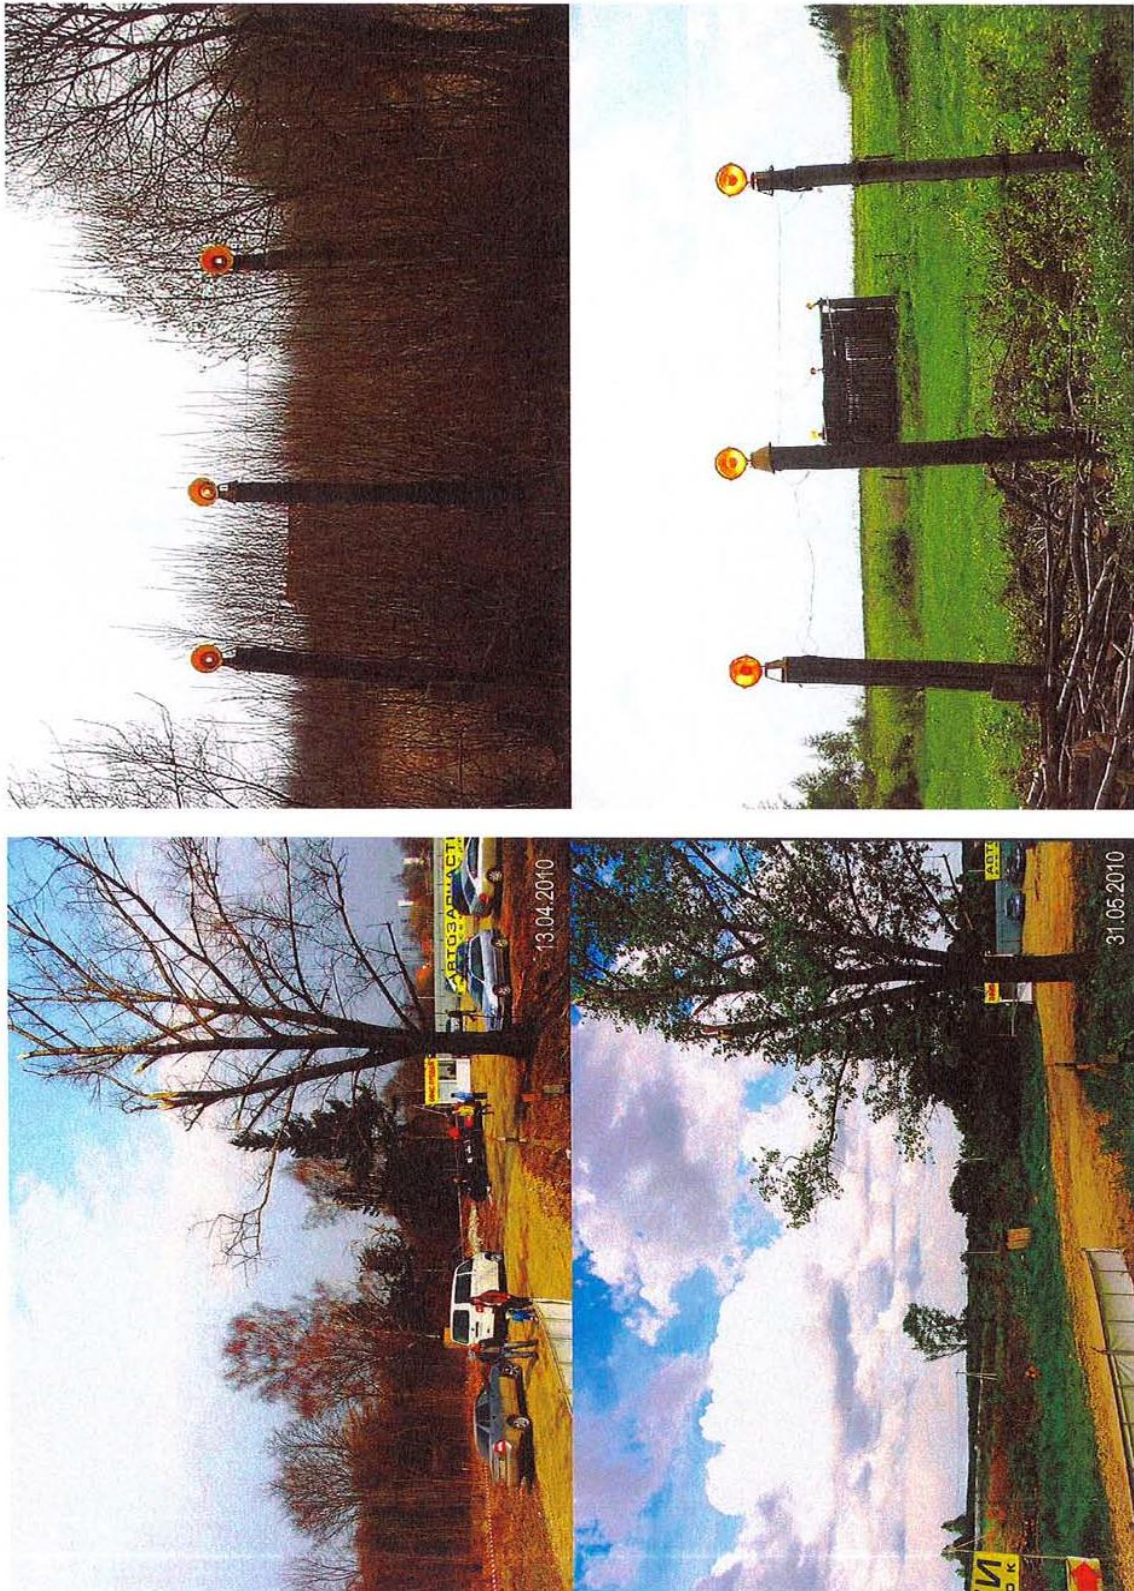
Differences in condition of the forest stand - area of the approach axis next to the motorway app. 600-650 m from the DS 26 threshold.
