Remarks
Of the Republic of Poland
as:
the state of registration and operator

on the draft Final Report
regarding
the investigation into the accident of the Tu-154M tail number 101 aircraft
which occurred on 10 April 2010
drafted by
the Interstate Aviation Committee (IAC)

Warsaw, 19 December 2010

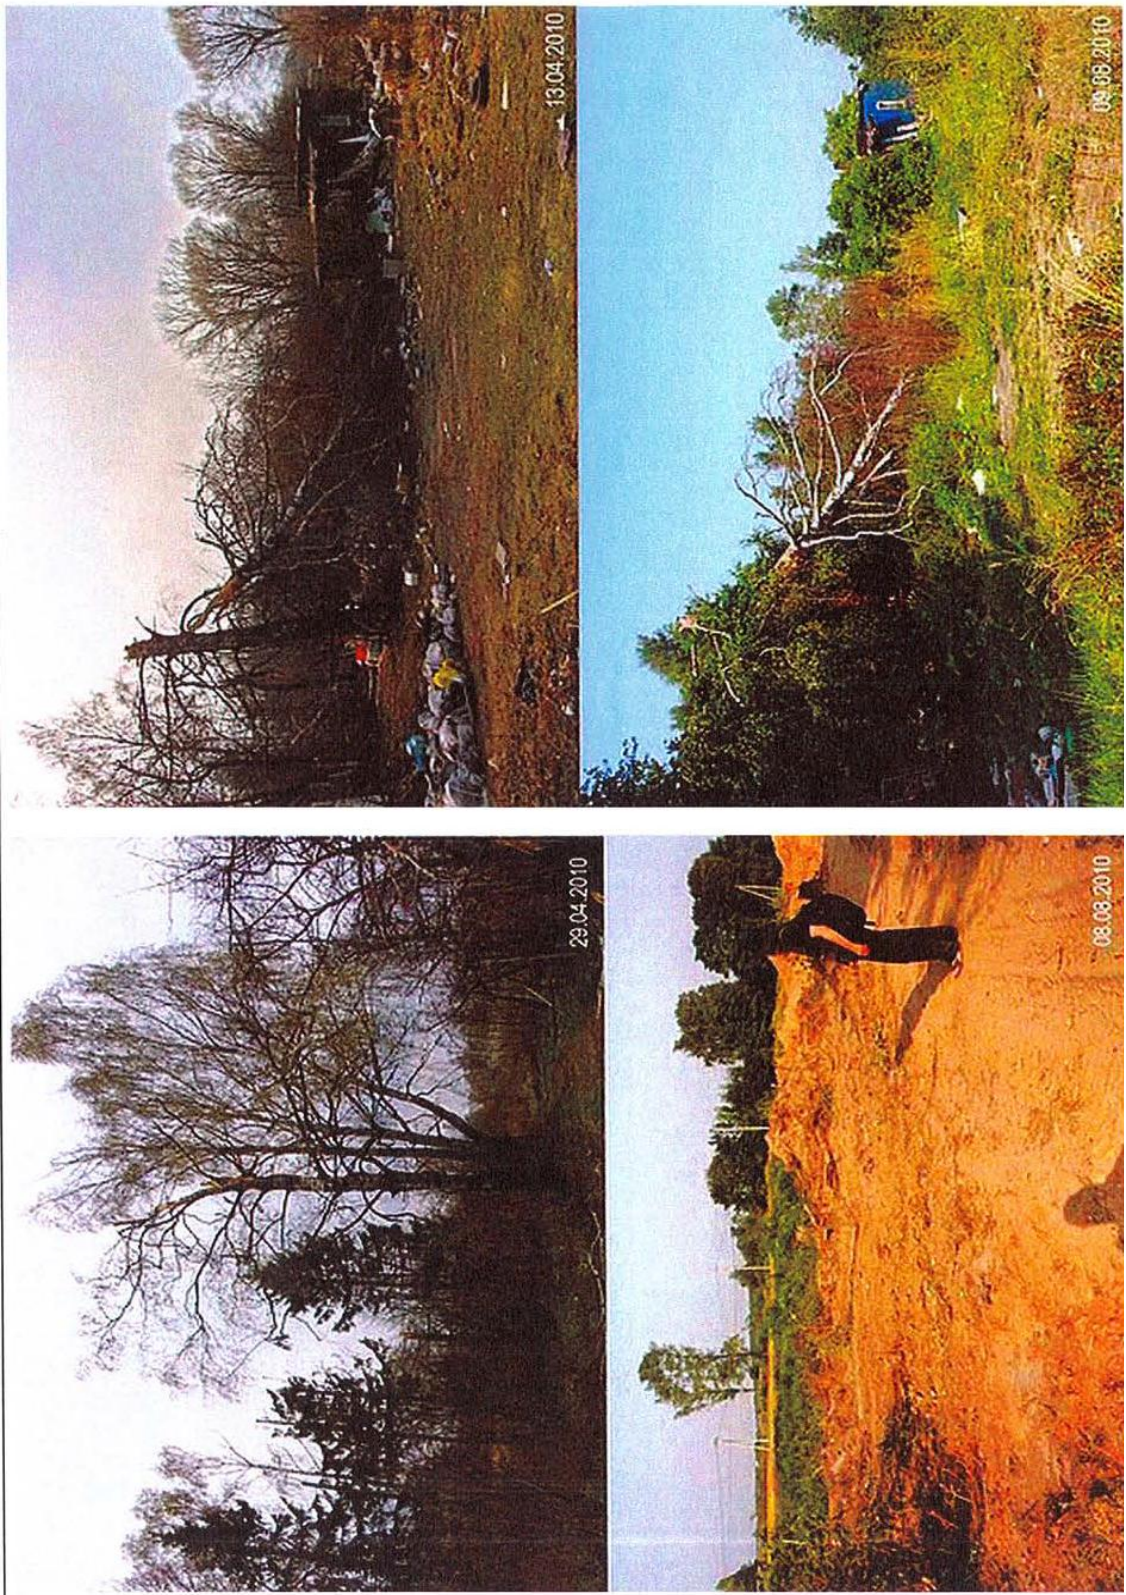
Differences in the condition of the forest stand – area at an approximately 700-800 m distance from the DS 26 threshold.

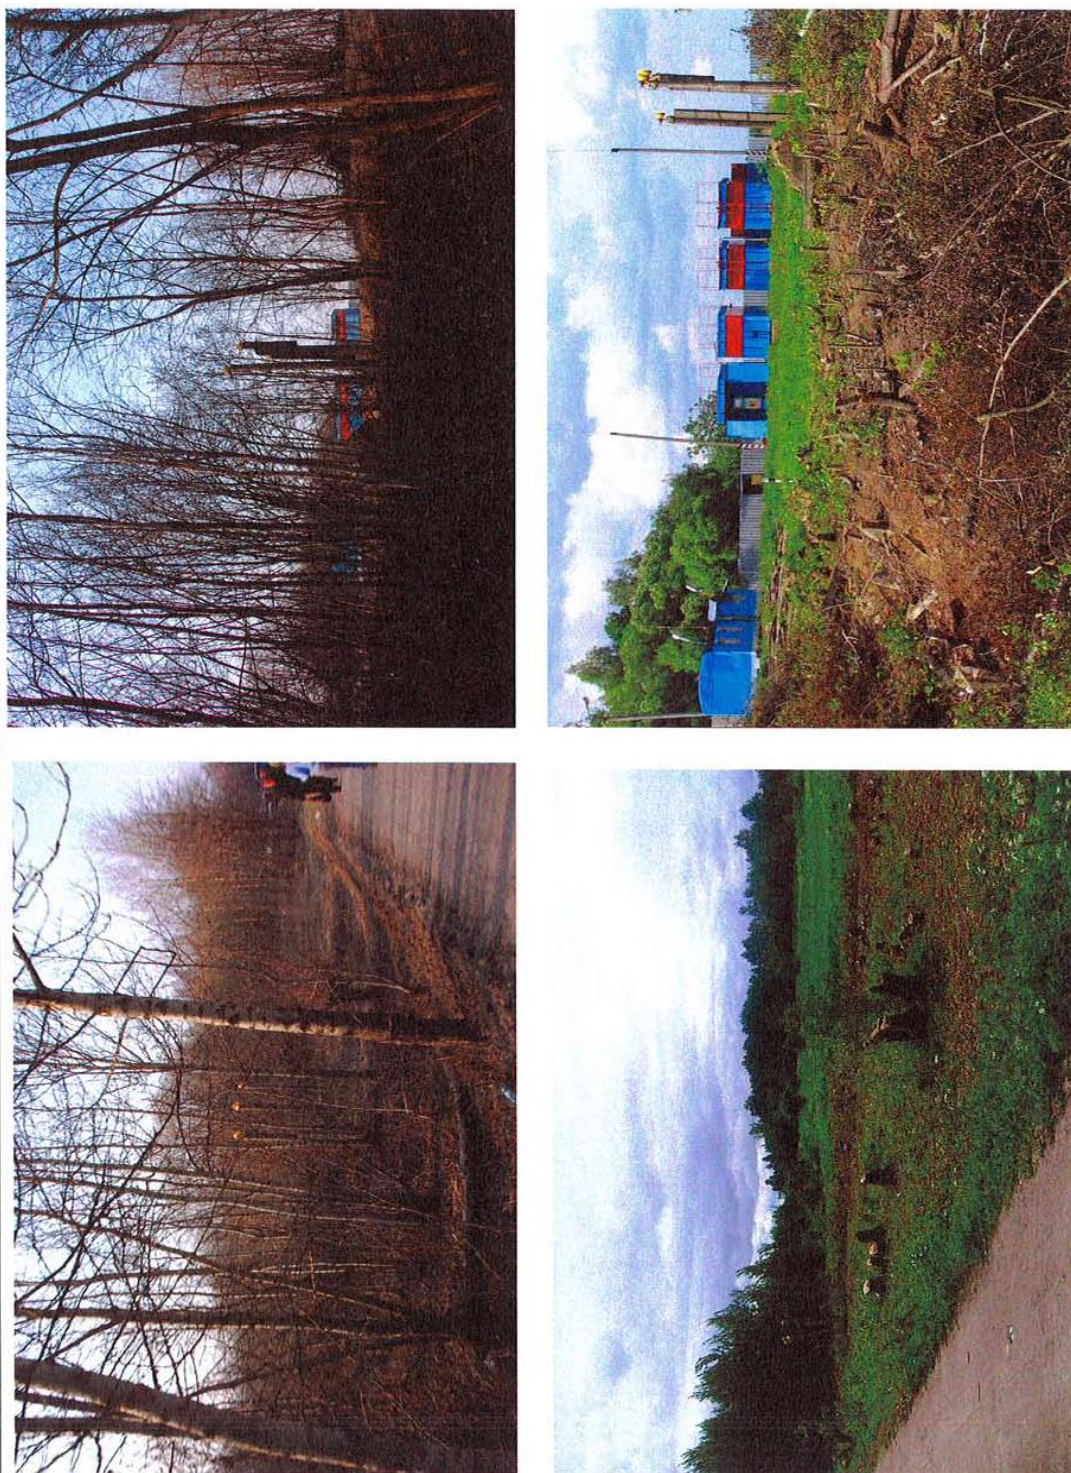
Differences in the condition of the forest stand – area of the approach axis app. 600 m and 700 m from the DS threshold.

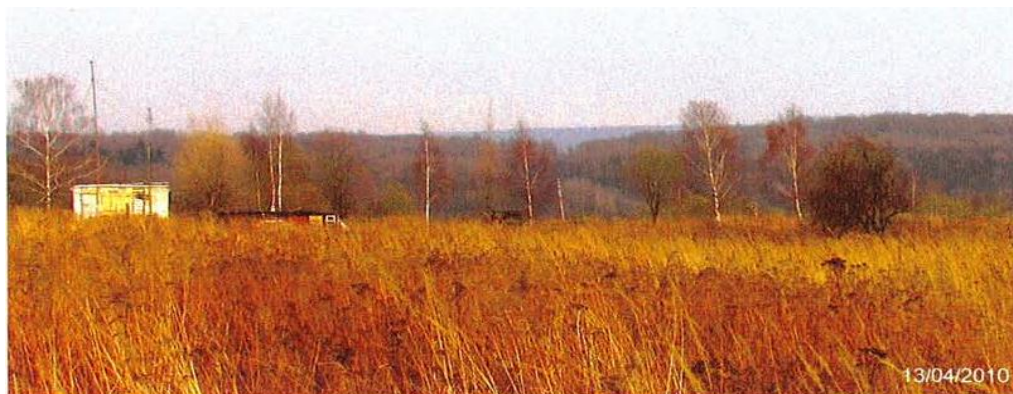
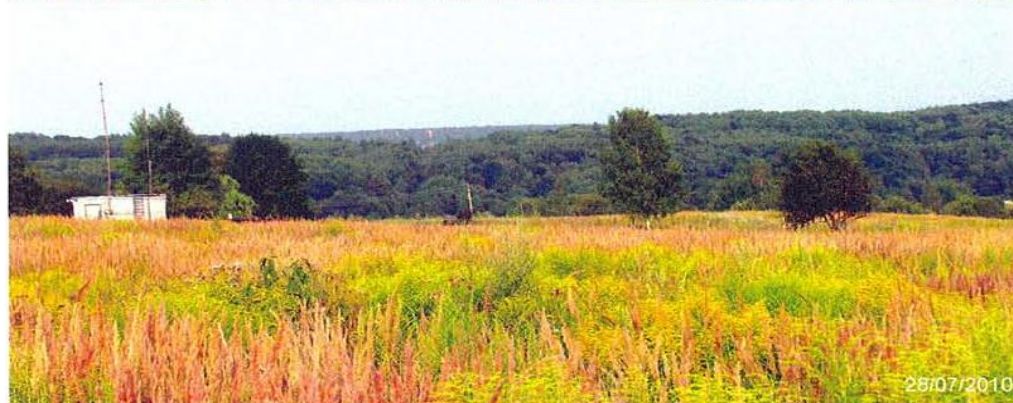
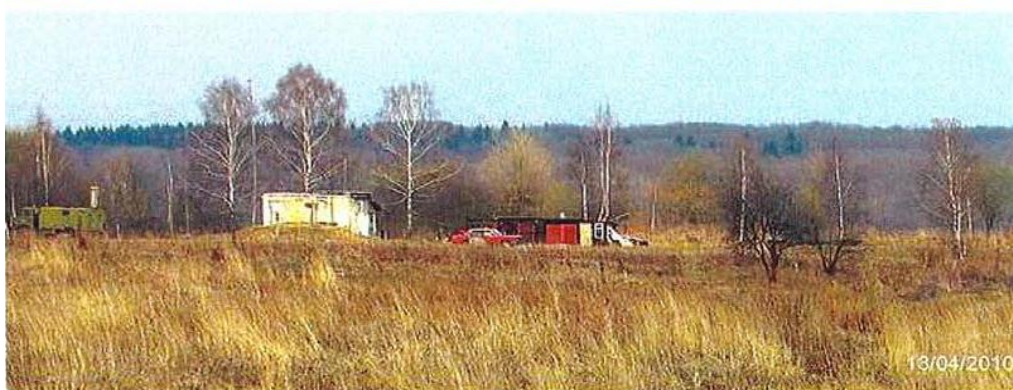
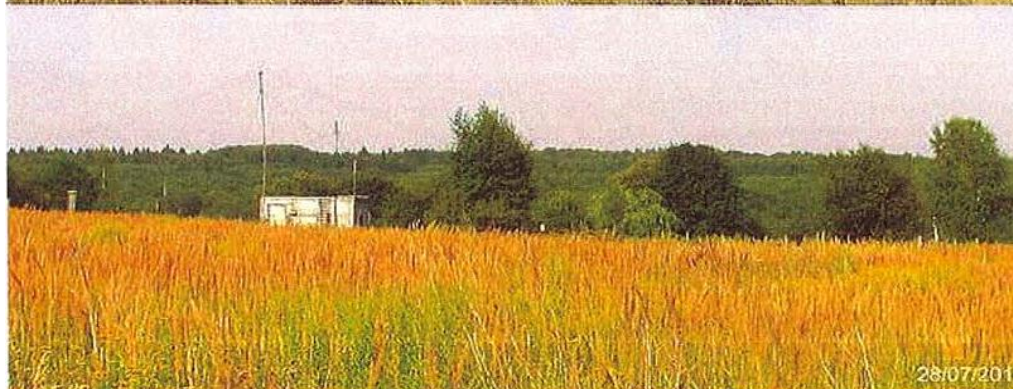
Differences in the condition of the forest stand - BRL area app. 1000 m from the DS 26 threshold.

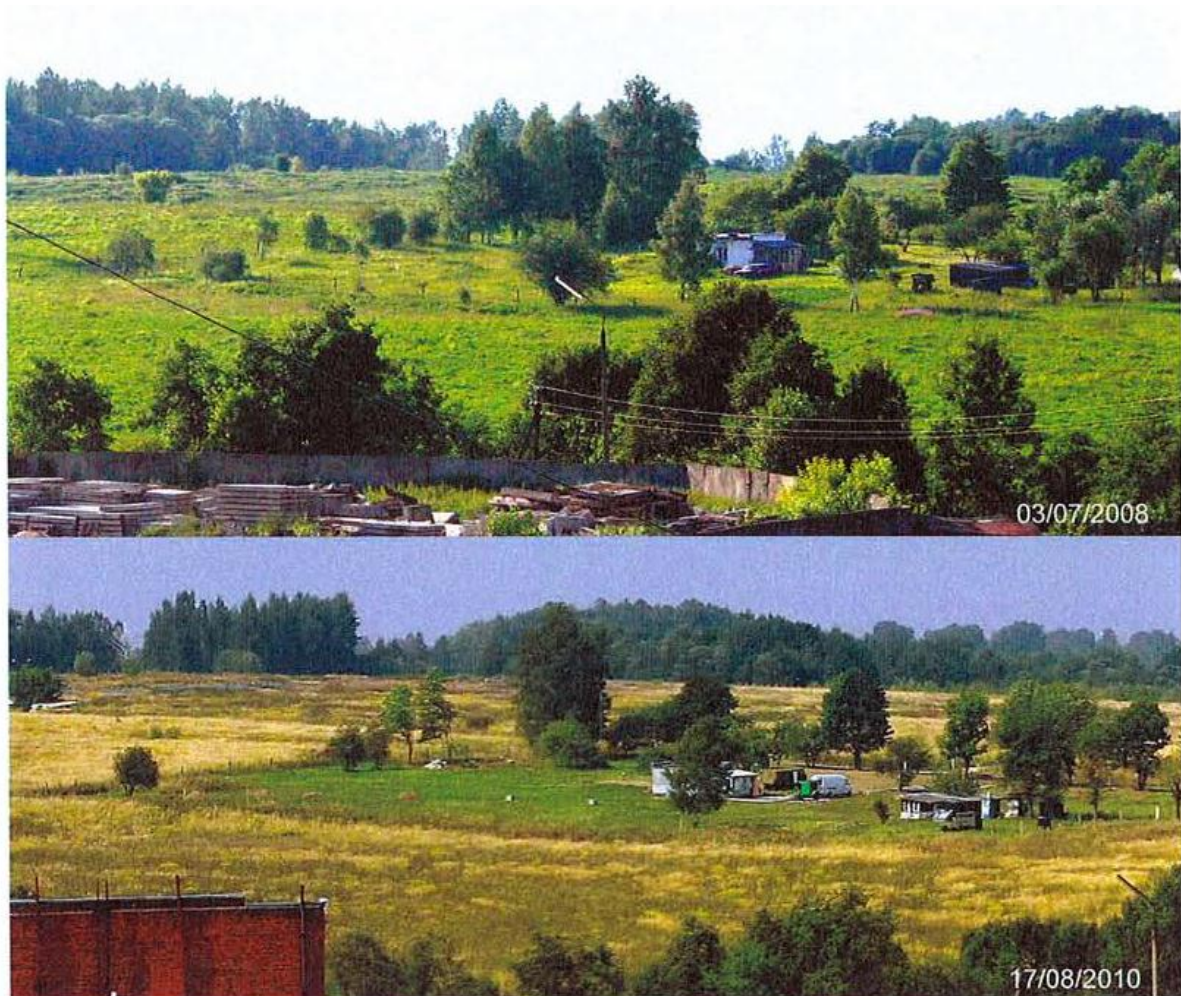
Differences in the condition of the forest stand - BRL area app. 1000 m from the DS 26 threshold.
